Storage Tanks: Snapshots of Failures, Damages and Inspections

Lessons learned from past failures provide insight and know-how needed to inspect and operate storage tanks reliably

Ana Benz
IRISNDT

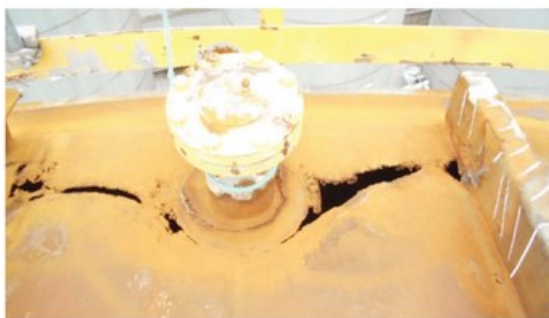
FIGURE 1. After removing the insulation, this tank roof showed numerous openings

sulation. After removing the insulation from a roof, inspection personnel identified numerous through-thickness openings in the roof (Figure 1).

Lesson learned about fixed-roof tanks. Do not walk on the roof without significant hazard diminishing strategies.

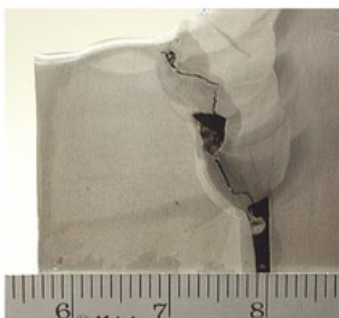
FIGURE 2. Cracks were observed in this tank shell-to-nozzle weld

During hydrostatic testing, an NPS 3 (nominal pipe size) tank drain nozzle leaked. The tank was fabricated to hold diesel fuel. The drain nozzle had one fillet weld joining it to the shell and another joining it to a reinforcing pad (repad), which is a plate formed

to the shape of the tank or vessel around a nozzle for extra strength. The welds had multiple cracks, porosity and non-fusion, as can be seen in Figures 2 and 3.

Lesson learned about welding the drain nozzle in steel tanks. Tanks are welded from the floor up. This means that access to this location (the drain) for welding is challenging. To prevent leaks, the welding passes can be deposited in multiple stages to prevent the formation of continuous leak paths. The hold times for the hydrostatic test should meet and exceed the standard requirements. Fluorescent liquid penetrant could make identifying a minute leak easier.

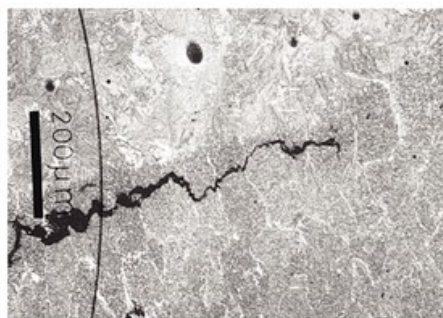
FIGURE 3. A closeup of the tank shell-to-nozzle fillet weld crack shown in Figure 2

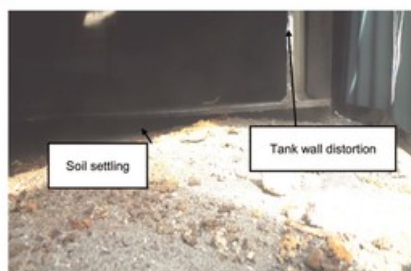
FIGURE 4. Shown here is the tank shell-to-bottom joint. Note the occurrence of soil settlement and tank wall distortion

A fertilizer service carbon-steel tank floor developed cracks in the tank wall to tank bottom joint, as shown in Figures 4 and 5. The cracks had the following characteristics:

These characteristics are consistent with the cracks being due to nitrate stress corrosion cracking (SCC). Additional stresses from the soil settlement under the tank resulted in distortion of the tank wall and floor. These stresses further contributed to the cracks forming.

Lesson learned about the tank floor-to-wall joint. Soil settlement needs to be monitored, and this critical joint (for carbon steels) needs inspection techniques, such as magnetic particles or eddy current, or both.

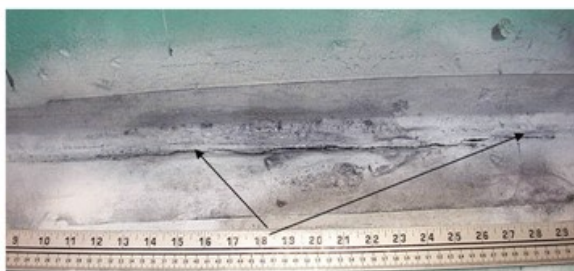
FIGURE 5. Cracks of the tank wall of Figure 4 are identified with magnetic particles

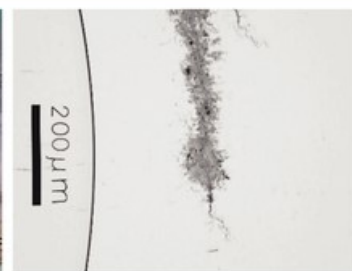
FIGURE 6. For the same tank shown in Figure 4, this metallographic cross-section of the tank floor shows intergranular cracks with oxides/corrosion products

- The cracks developed in the cross-section with the highest stresses in the storage tank. Hydrostatic and welding residual stresses are maximum on this joint
- The cracks had some oxides/corrosion products (see Figures 6 and 7)
- The cracks were intergranular

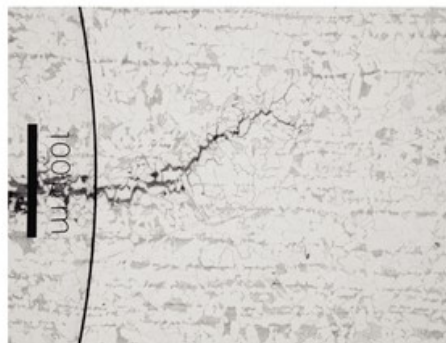
FIGURE 7. Another view of the metallographic cross-section of the tank floor (Figure 6), which shows intergranular cracks (2% Nital etch)

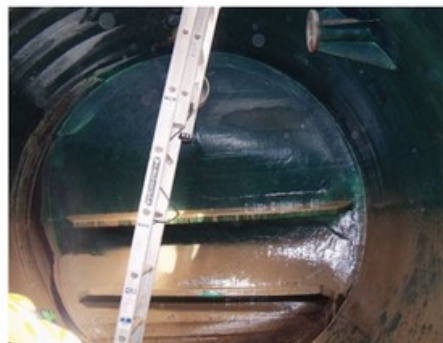
Examining the tanks from the inside, the shape was oval (Figure 8). Also, many of the joints were “whitened.” “Whitening” can develop when FRP is subjected to localized stresses (Figure 9). These damages suggested the tanks had experienced excessive compressive displacement during their partial lift.

FIGURE 8. This septic tank's inside diameter was oval. The internals had separated from the shell

The damaged tanks were replaced. Soil, in accordance to strict (and necessary) installation guidelines, was used to install the replacement tanks. The flow of the underground stream was diverted away from the tanks. The replacement tanks were installed without further surprises.

Lesson learned about installing FRP septic tanks. Buried FRP tanks require special installation practices heralded by their suppliers. Thorough evaluations of the soil con-

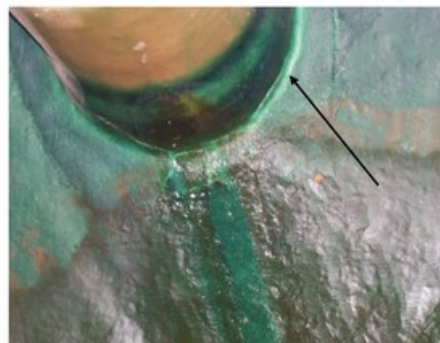
FIGURE 9. For the same septic tank of Figure 8, many of the inside joints had whitened — an indication of localized stress

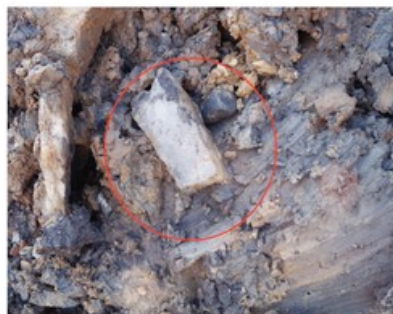
- The soil surrounding the tanks had 0.3 m × 3 m × 0.1 m chunks of ice (Figure 10). Some of these ice chunks had been pressing against the tank shell. FRP is prone to cracking when subjected to localized compressive loads
- The day before the author left the site, an intermittent underground stream was noted a couple of meters below the ground level. The flow was directed at the tanks and would have eroded the ground and support for the tanks, once installed

FIGURE 10. During a summer excavation, large chunks of ice were identified surrounding the septic tank of Figure 8

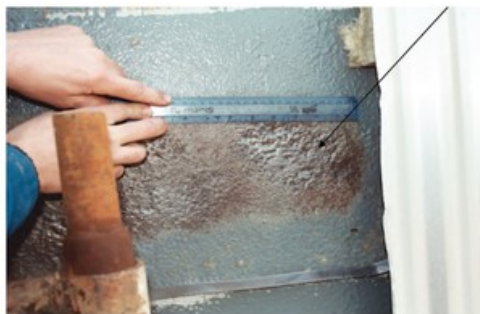
FIGURE 11. Tank floor pits are identified with acoustic emission non-destructive testing

Acoustic emission (AE) testing of FRP and of ammonia tanks. AE tests of FRP and ammonia tanks provide volumetric tests of shells of the tanks while in service. Entry is not required, avoiding the potentially damaging process of shutting and exposing the tanks to air (when ammonia tanks can develop stress cracks) and thermal stresses for ammonia service. The tests aim to detect and locate areas of concern. Figure 11 shows tank bottom pits identified with acoustic emission. Follow-up inspection with a complementary non-destructive testing (NDT) method is needed to identify and size any AE indications for ammonia steel tanks. FRP tanks require visual follow-up.

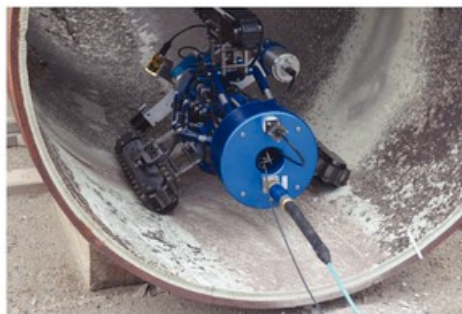
FIGURE 12. Using robotics for visual and coating inspections can reduce the need for personnel to enter confined spaces

holds the promise of robotics being used for tank thickness, visual and various other internal inspections for multiple other services (Figure 12). This would reduce the need for personnel to enter confined spaces and the time and budgets needed for emptying and storing tank contents elsewhere. However, cleaning and navigational challenges are today the obstacles that need to be overcome. ■
